Two North Shore residential upgrades

Project 1: 49B Upper Pitt St, Kirribilli

Project 2: 168 Kurraba Rd, Neutral Bay

Large roof membrane on the Seymour Centre

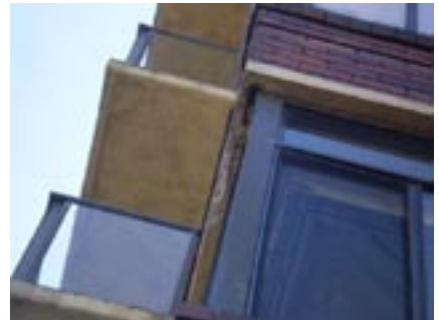
Corrosion of posts, spalling slab

- Replace window corner posts due to severe corrosion of the posts and displacement of the surrounding brickwork
- Repair concrete slab edges and soffits
- Remove all exterior lintels, Install

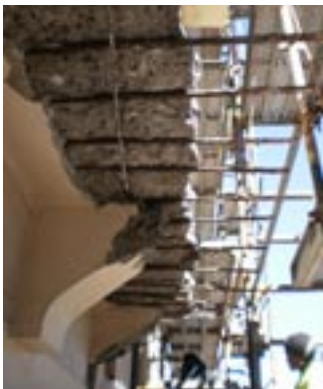
Left: Walls rebuilt and stabilised before formwork erected. Right: Concrete mix pumped to balcony sites ready for membrane and tiling

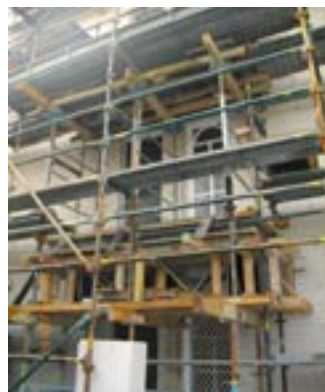
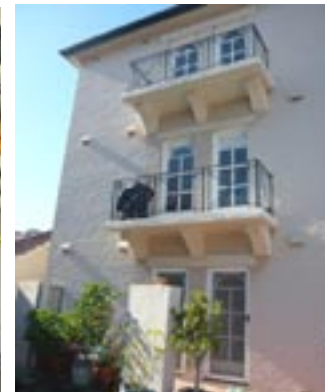
The balconies were constructed using coke breeze concrete and once break-out started, it became evident we could not save the slabs.

All balconies demolished due to reo corrosion

Typical balcony demolished back to brickwork

This exposed the outer skin of brickwork, which also revealed stability issues. Once the brickwork was reinstated, new reinforcement was put in place, formwork installed

and the balconies cast with ready mix concrete.

Also additional support columns were designed and installed for all balconies. Once cured, the

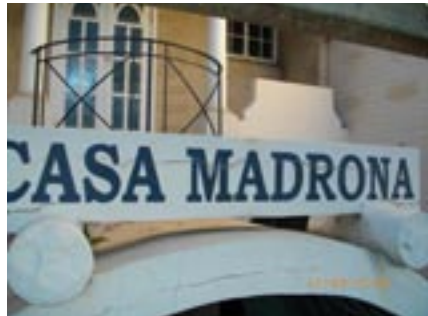
The main entrance canopy was to be repaired using conventional concrete repair techniques. However once initial break-out commenced, it became evident that the cost would be prohibitive, such was the deterioration.

←close-up of existing canopy before repair

A new support structure was erected under the canopy so that the demolition work could be undertaken safely. Then a new formwork system was installed to replicate the curved entrance.

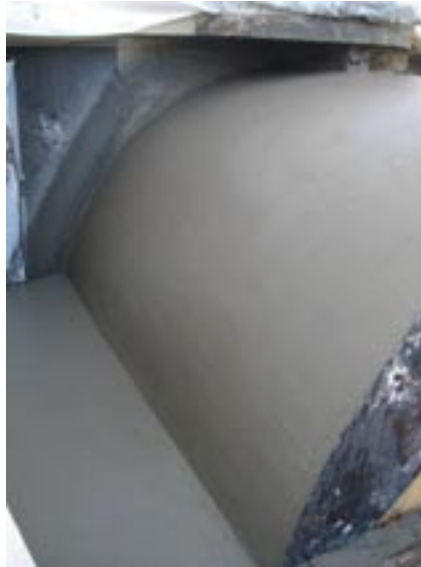
Finishing off the concrete

Once in position, the concrete was finished off and cured with a curing compound.

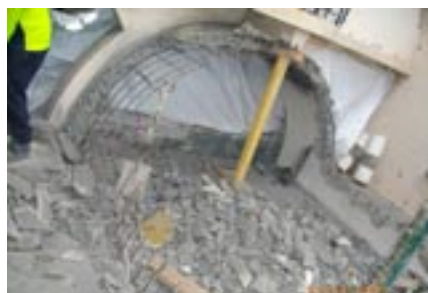
Entrance canopy demolished

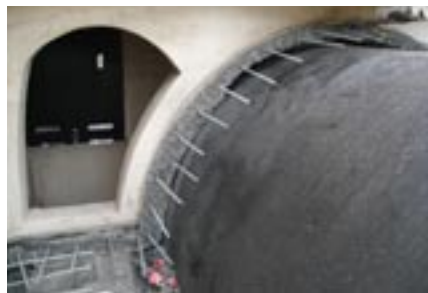
Formwork & doweling in place

Dowelling of steel into the building and installation of the steel reinforcement for the structure followed.

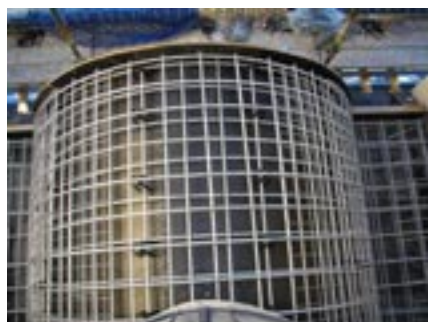
Steel reinforcement in place

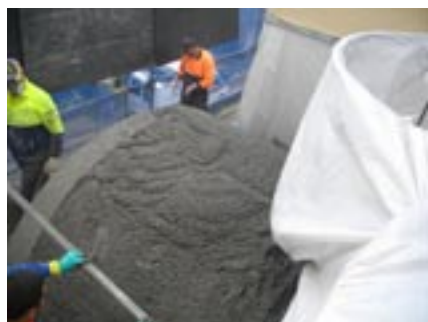
Concrete placed over formwork

Ready mix concrete was then pumped from the street onto the formwork and shaped to replicate the old canopy.

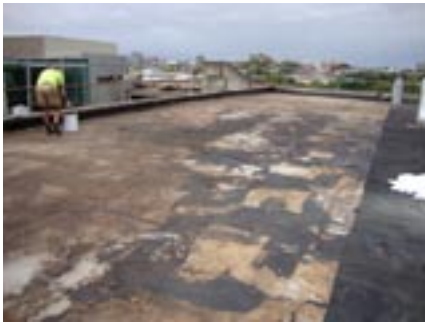
Distinct roof sections stripped, primed and covered

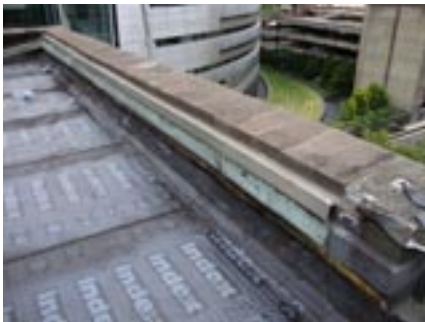
Detailing was a significant element of the works due to large perimeter areas

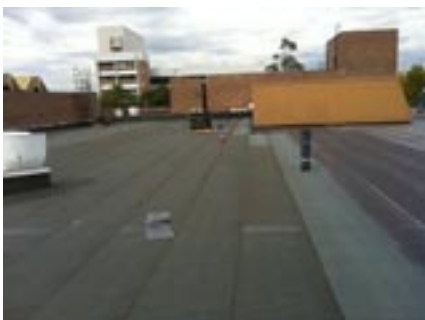
Mineral finish layer installed and detailed
