PRESERVATION TECHNOLOGIES

Team restores failing exposed aggregate render

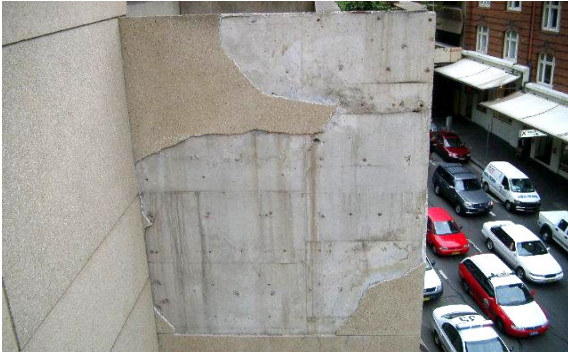
Above: Delaminating render. Below: Safety hoarding also catches repair process water

The problem: An investigation found that the existing exposed aggregate render, reinforced by a thin mesh, was delaminating from the concrete elements of the structure. The failed area was directly over the main entry to the Council of Sydney's building in Kent Street, as well as being a busy pedestrian thoroughfare from Town Hall Station and St Andrews School.

The solution: Following submission of plans to the facility manager and a permit application, a B Class hoarding was erected and totally closed off to seal the area above. A fixed, enclosed scaffold was erected off the hoarding and around the structure. Removal of render and drilling into the building was carried out after hours and on weekends.

The methodology: The initial work involved producing a trial sample to ensure the new render would match the old in texture and colour. New stainless steel mesh was mechanically fixed to the concrete and an initial skim coat was troweled on using a pre-bagged polymer-based render. To this layer a second build coat was added before the final aggregate-filled render was applied. This was then exposed to match the existing surface. Also a planter box at the top of the structure was totally renovated using a torch-on membrane.

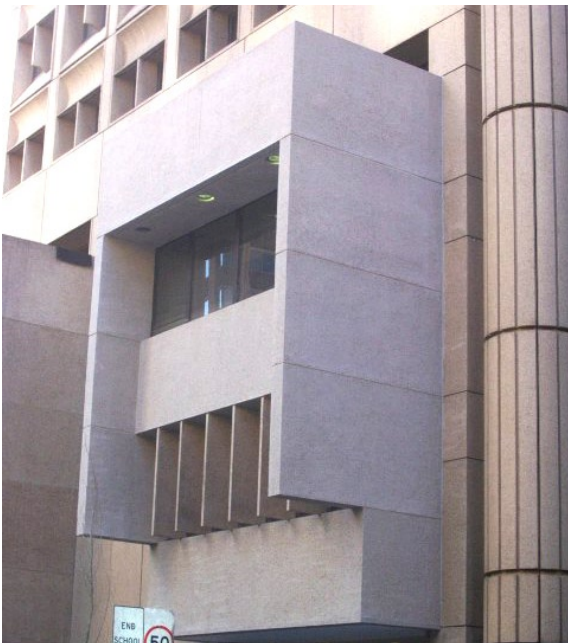
Restored facade area matches existing facade

The result: The repaired facade area is now once again secure and blends in with the adjoining building elements.
