## Rope access team repairs joints and seals dam wall

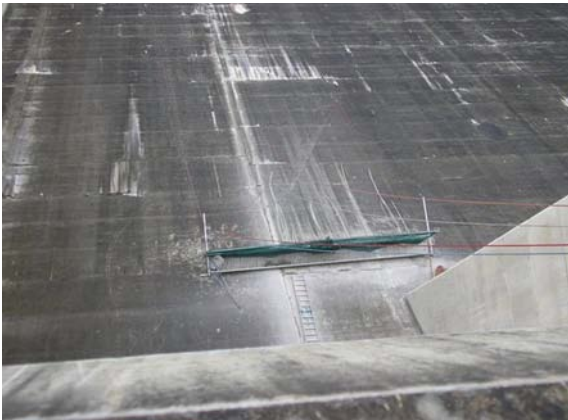
*The work platform hangs down the dam face with a net underneath to catch dangerous "fall-out"*

**The solution:** To minimise the cost of accessing the dam wall face, a specially designed rope access system was developed incorporating a suspended work platform with a catch net to prevent slippage of debris and materials down the dam face.

**The methodology:** Following the development and sourcing of key components of the access system and signing off the extensive safe work practices by the client, the site team set up the rope system to gain access to the dam wall face. From here the platform and hoisting system was constructed and put into position for the first repair area.

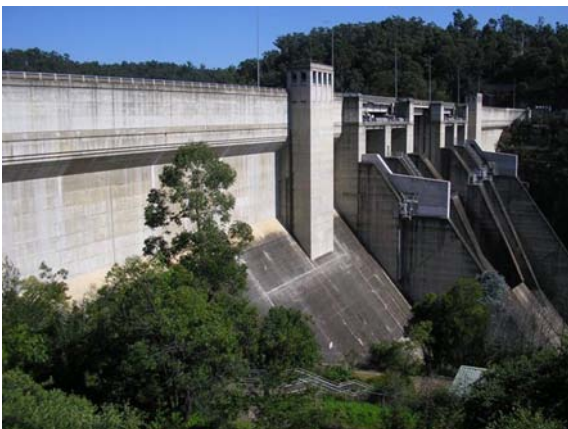
*Repairs to the dam wall were completed safely*

**The problem:** Existing joints in the dam wall were allowing water to seep inside the wall and particularly into a chamber area where electrical equipment was installed.

The existing joint sealant was removed and the joints cleaned out. In the many areas where the edges had deteriorated, the joints had to be reconstructed. These edges were built up using a polymer-modified concrete repair mortar. Once cured, the joints were primed and then sealed using a high performance joint sealant system. Having finished one area, the team moved the platform to another location and so on until the work was completed.
