## Watsons Bay ferry wharf receives overdue repair

**Asset owner:** Sydney Ports

**Completed:** August 2007

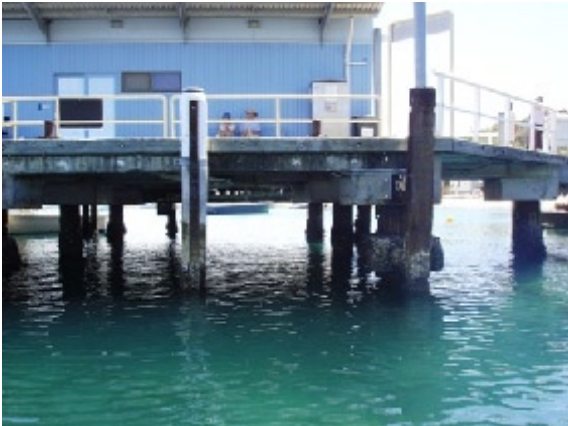
*Project overview prior to demolition and repair*

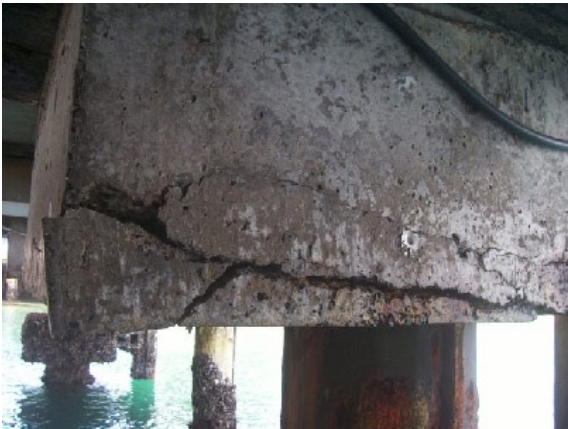
*Reinforced concrete pile caps had deteriorated badly at tidal level*

**The problem:** Years of chloride ingress into the concrete structure had caused severe deterioration of various elements of the wharf, particularly in the tidal zones of the concrete pile caps and some reinforced concrete beams.

**The methodology:** Following installation of the access system, the repair team removed the deteriorated concrete. The repair areas were suitably prepared including any steel replacement.

These were then formed up and a fluid micro-concrete repair material was mixed and poured into the formwork. Once the repair mortar had gained sufficient strength, the formwork was removed and, where required, the repairs were finished off using a hand-applied high-build repair mortar.

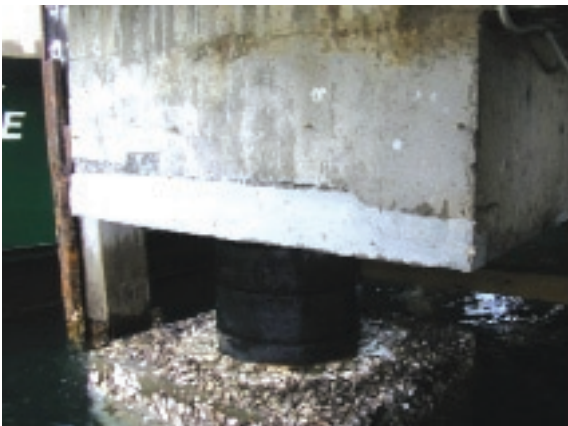
*Repair area formed and poured ready to finish off*
