PRESERVATION TECHNOLOGIES

CASEFILE

Renew heritage facades, towers, statues and roof areas in CBD building despite city confines

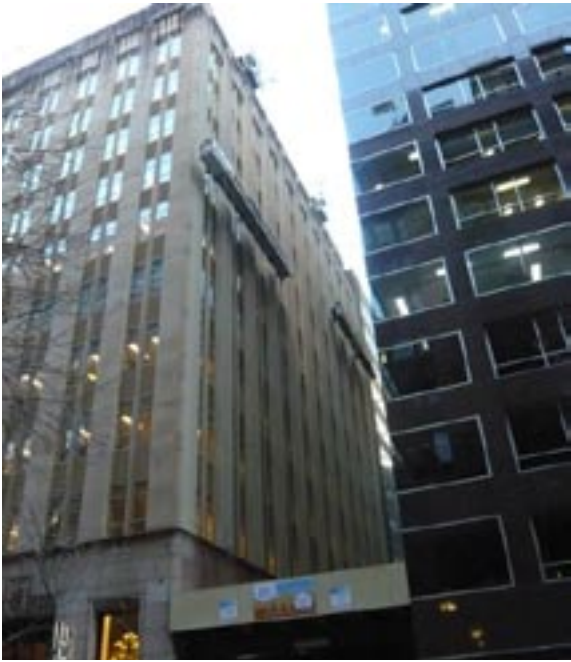
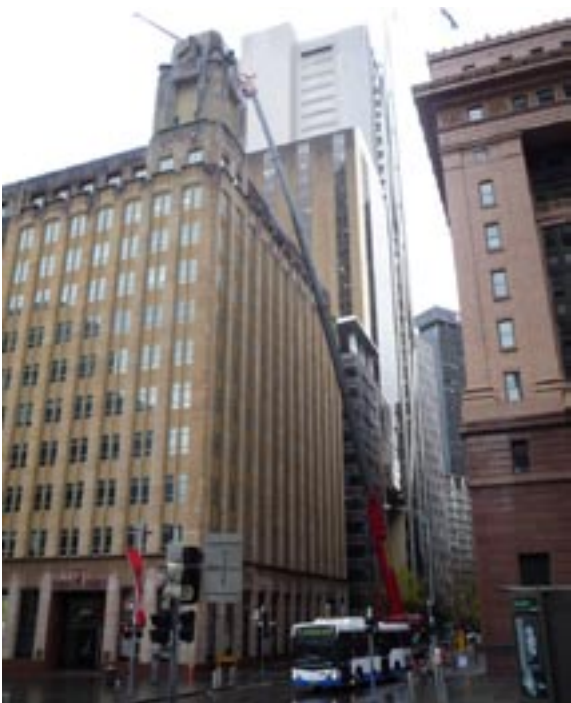
Above: Swing stages over hoardings for investigation, and repairs Below: Crane lowers pavers

Stage 1 called for the team to crane down 2200 large concrete pavers (100 tonnes) from the roof. Also to remove old steelwork, planters and furniture.

Stage 2 began with setting up roof access points into swing stages to allow repair teams firstly to investigate the reinforced concrete mullions using a cover meter survey, carbonation testing, chloride testing, a photographic record and documenting of observations made, in part requiring rope access.

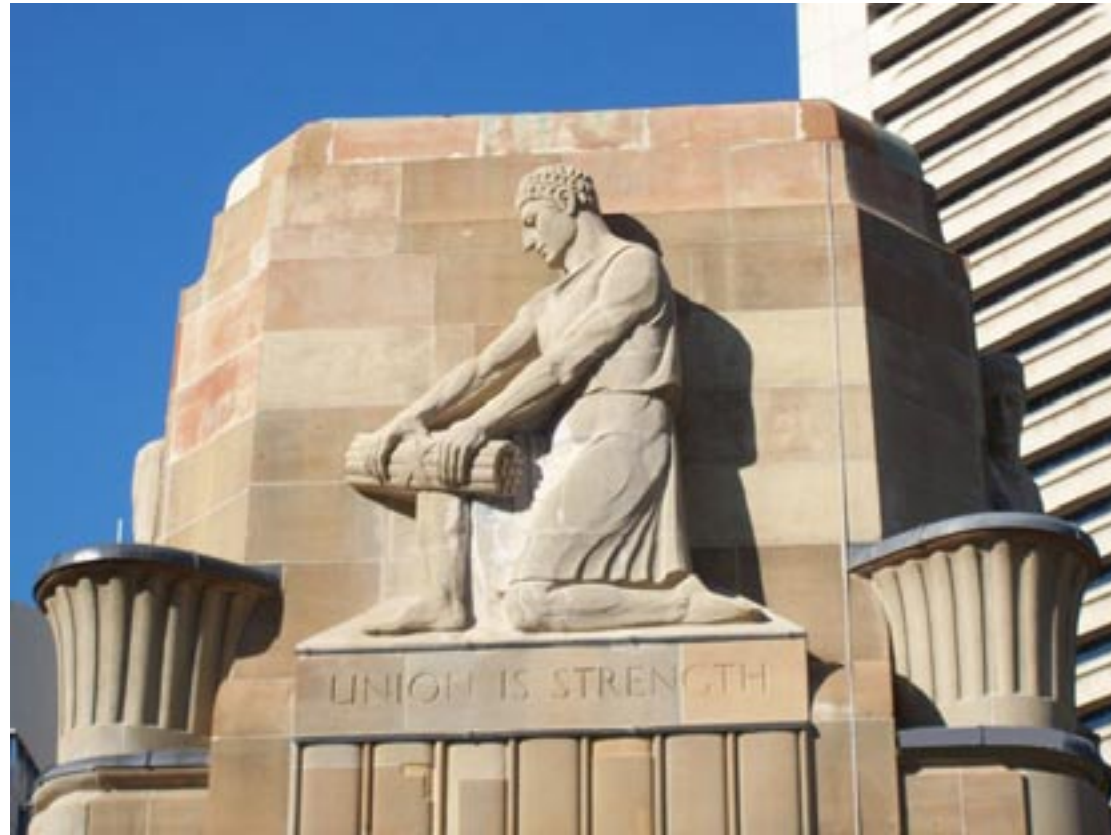
Left: As magnificent as it was, the statue, including its surrounding stonework, had lost its grandeur due to the ravages of time and weathering

Grand statues on each tower face were repaired, repointed and sealed against environmental damage. The parapets and all of Level 10 were cleaned prior to the parapets being capped in detailed lead weathering.

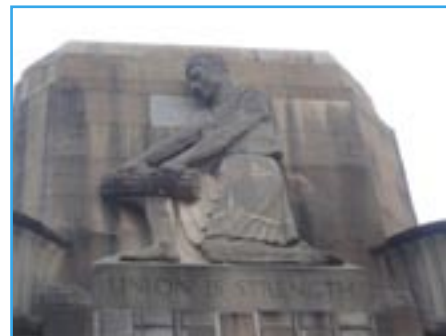
Above: this statue, as others on the building after being repaired and treated— including lead weathering— were returned to their former glory

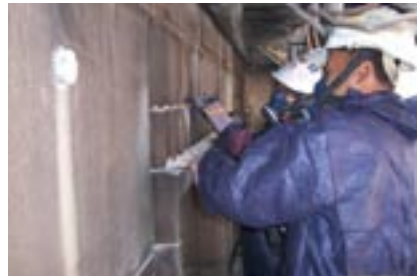
Removal of contaminated mortar

Before the workteam repointed all the Level 10 sandstone, they used special OH&S removal protocols on the bedding mortar, which was contaminated with asbestos.

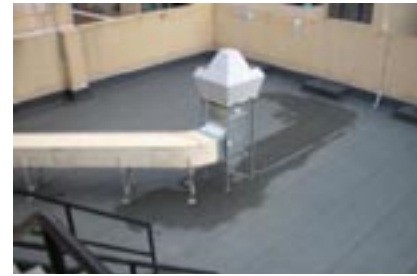
Roof membrane applied to roof

To the cleared roof, a two layer torch-on membrane was installed, including detailing to walls, plant areas and drains.

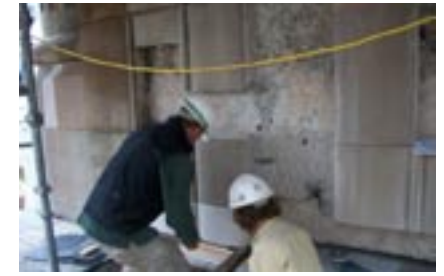
Installing new stonework

After a condition review of sandstone elements, most of the Level 10 sandstone lintels were demolished and prepared for new 400 kg sandstone lintels to be moved and fitted into place. This included preparation and fireproofing the rear of each lintel.

The stonemasons removed and replaced other deteriorated sandstone to the facade and “combed back” fretted stonework.

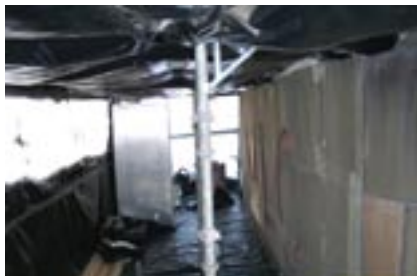
Asbestos removal encapsulation

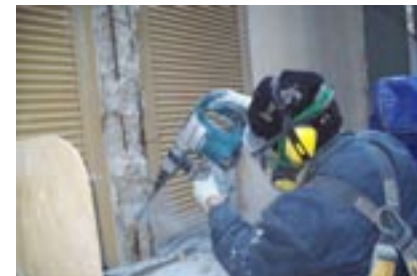
Typical mullion repair detail

Based on this, the workteam mapped out the repair strategy for reinstating the reinforced concrete and rendered window mullions running the full height of the facade. The team also fixed and sealed windows and protective coated the mullions.

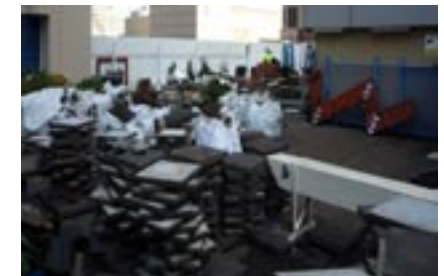
Pavers prepared and removed

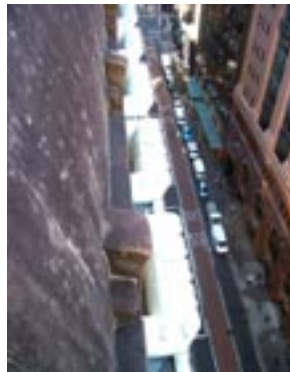
Parapet badly environmentally stained (left) has been repaired, repointed and cleaned with Juliet type balconies waterproofed and protected (right)

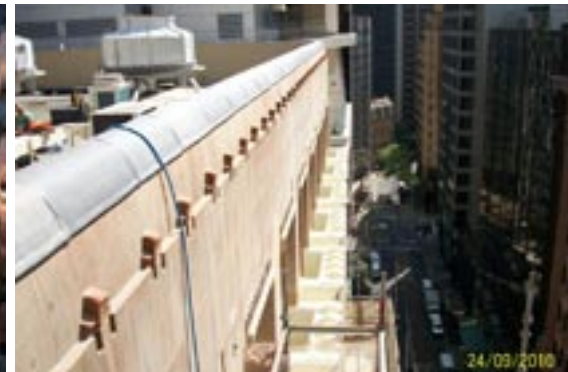
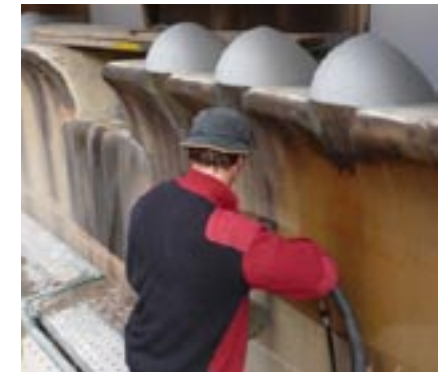
Cleaning stonework to all of the parapet and Level 10
