## Harbour-side tower building gets protection

One of Sydney's most prestigious apartment complexes - Quay West Apartments was identified as requiring remedial works to its facade to address reinforcement corrosion issues and UV degradation of the existing coating.

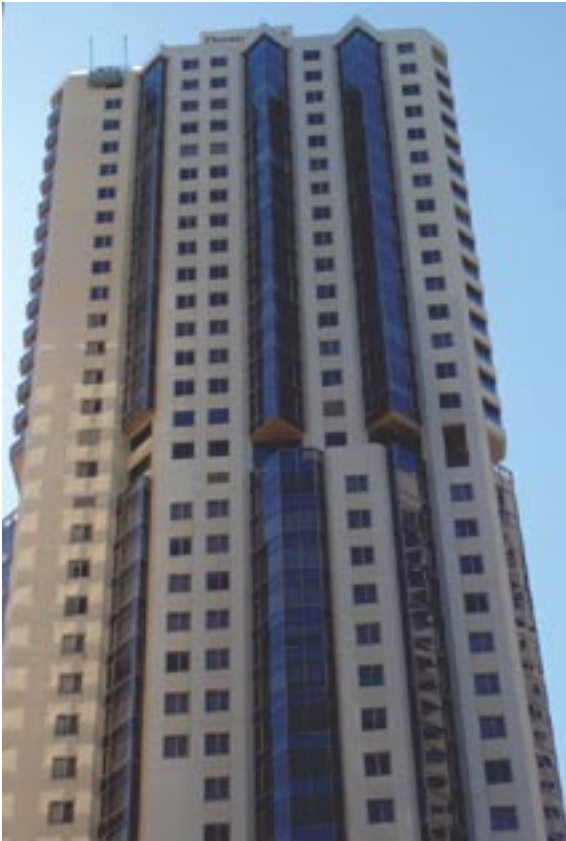
*Application of protective coating to western elevation under way*

**The methodology:** Elevation by elevation, the teams first undertook concrete repairs then waterblasted the surface. They applied protective membrane coating in two coats to all concrete elements. In addition, the coating was applied to all roof areas with some areas requiring additional access systems. Roof signage was also cleaned. Above the sloping roof areas, the team membraned a flat level roof and replaced and painted missing and deteriorated metalwork. They cleaned the roof area pathway, membraned the gutter and painted the concrete.

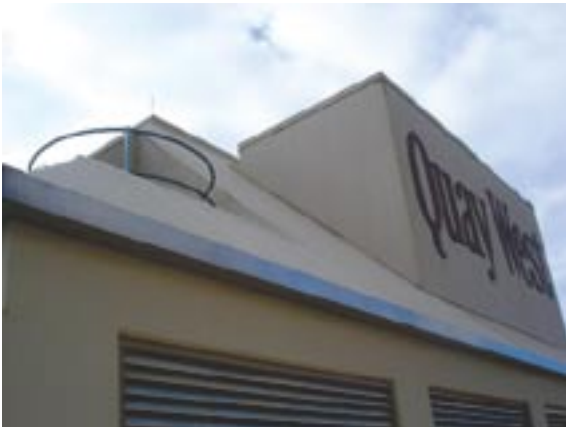
*All roof areas had to be accessed for coating and waterproofing works as well as metalwork replacement*
