## Inner city residential facade repair and restoration

## Stage 2 residential facade repair and restoration

**RE: SMITH STREET, SURRY HILLS  
FACADE RECTIFICATION WORKS - STAGES 1 AND 2**

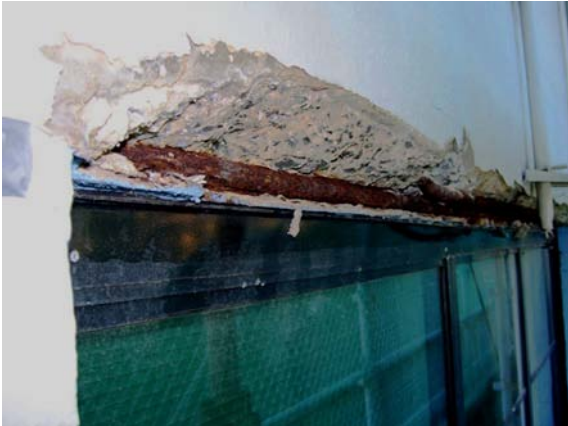
*This was typical of the deterioration of the lintels*

**The methodology:** Specialist teams removed and replaced the lintels, which included extensive new brickwork rebuilding and repairs to timber joists. All lead-based coatings were removed, the surface prepared and sealed with an epoxy primer, and a new membrane coating applied over this. New aluminium windows were installed to overcome the leaking issue.

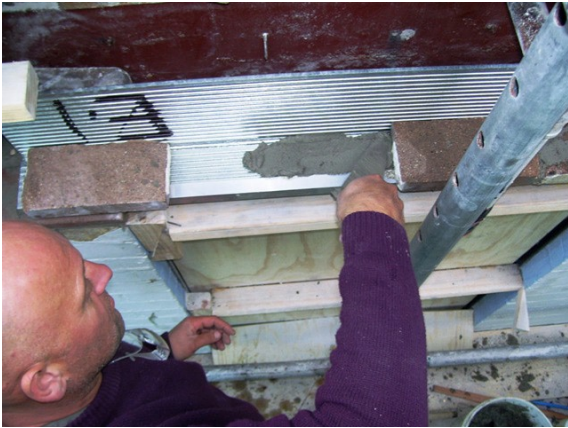
*Lintels were built after major prep work internally*

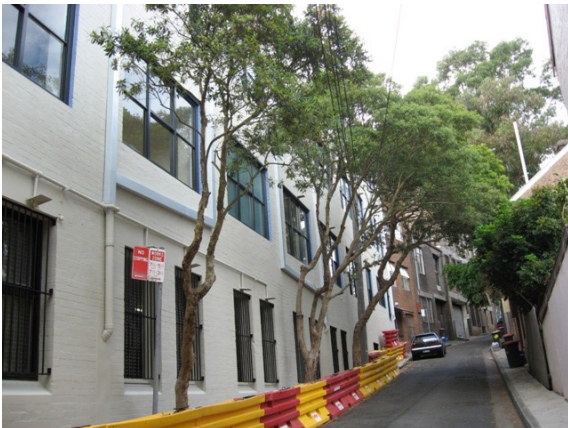
*Facade done, with work zone yet to be removed*

**The solution:** Following extensive negotiations and planning with Council, a work zone was created along the wall area, a fixed scaffold system was built off the footpath, trees were cut back, and the wiring protected and isolated. Cars were able to park along the work zone while still allowing other vehicles to

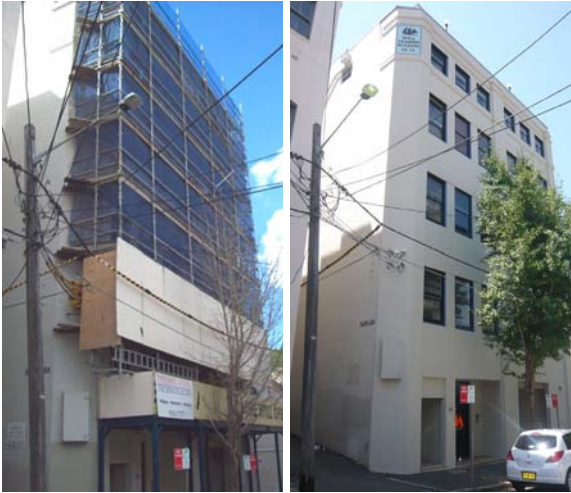
*Left: Access to the southern elevation, and  
Right: The southern elevation repaired and coated*

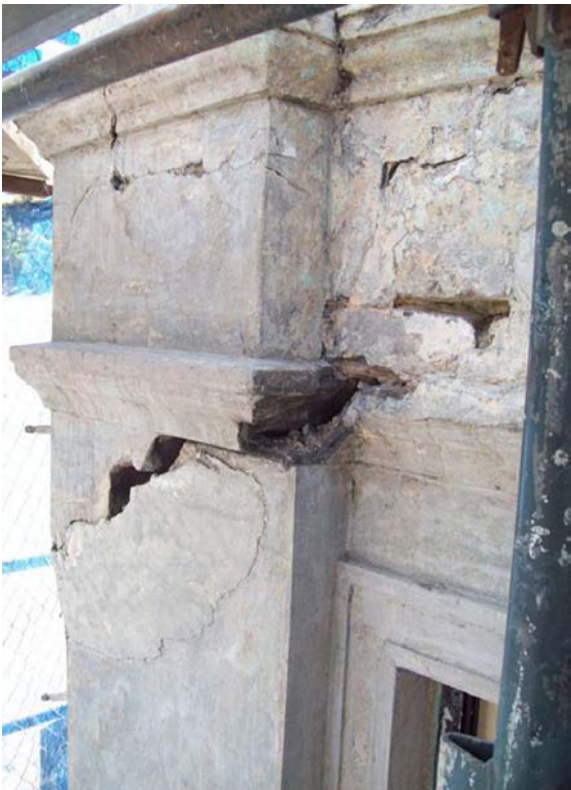
*After major preparation work internally, the  
lintel had to be completely rebuilt*

**The methodology:** Using the same specialist teams from Stage 1, the project followed similar lines as before. All reinforced concrete lintels were either removed and replaced with "T" bars and brickwork, or were repaired using concrete repair techniques. All lead based coatings were removed from the facade, the surface prepared and sealed with an epoxy primer and a new membrane coating applied over this. New aluminium windows were installed to match the southern elevation.
