Two North Shore residential upgrades

Project 1: 49B Upper Pitt St, Kirribilli

Project 2: 168 Kurraba Rd, Neutral Bay

Large roof membrane on the Seymour Centre

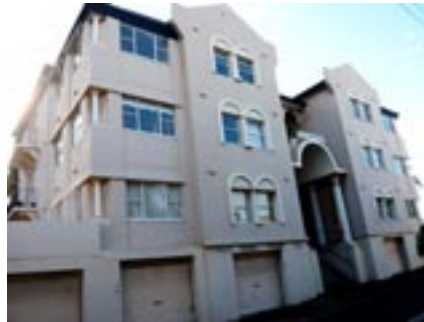
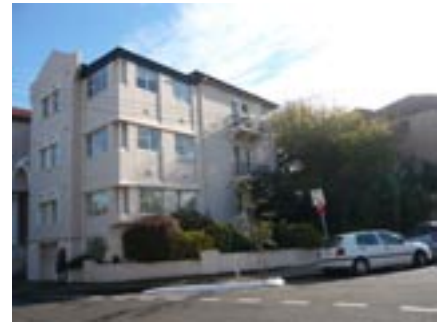
This beautiful old building, "Casa Madrona", had suffered the ravages of time, particularly concrete deterioration of balconies, the main entrance canopy, garage and stair soffits, as well as water ingress into some units and the garages. Generally the building required a full facelift including repainting.

Before: Kurraba Road frontage (left) and elevation (right)

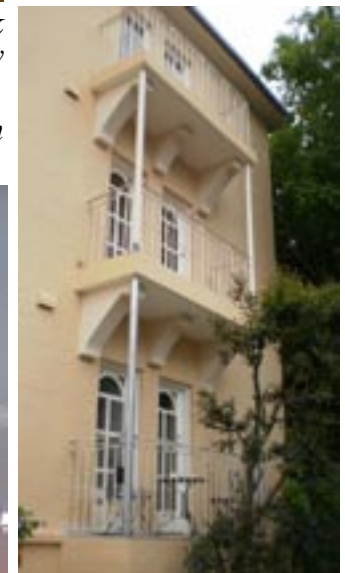
All balconies demolished due to reo corrosion

Typical balcony demolished back to brickwork

This exposed the outer skin of brickwork, which also revealed stability issues. Once the brickwork was reinstated, new reinforcement was put in place, formwork installed

and the balconies cast with ready mix concrete.

Also additional support columns were designed and installed for all balconies. Once cured, the

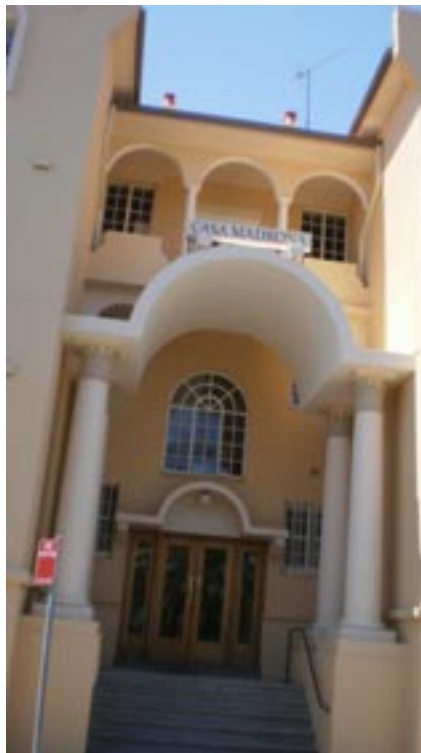
The entrance canopy after being expertly restored and protected

The main entrance canopy was to be repaired using conventional concrete repair techniques. However once initial break-out commenced, it became evident that the cost would be prohibitive, such was the deterioration.

A new support structure was erected under the canopy so that the demolition work could be undertaken safely. Then a new formwork system was installed to replicate the curved entrance.

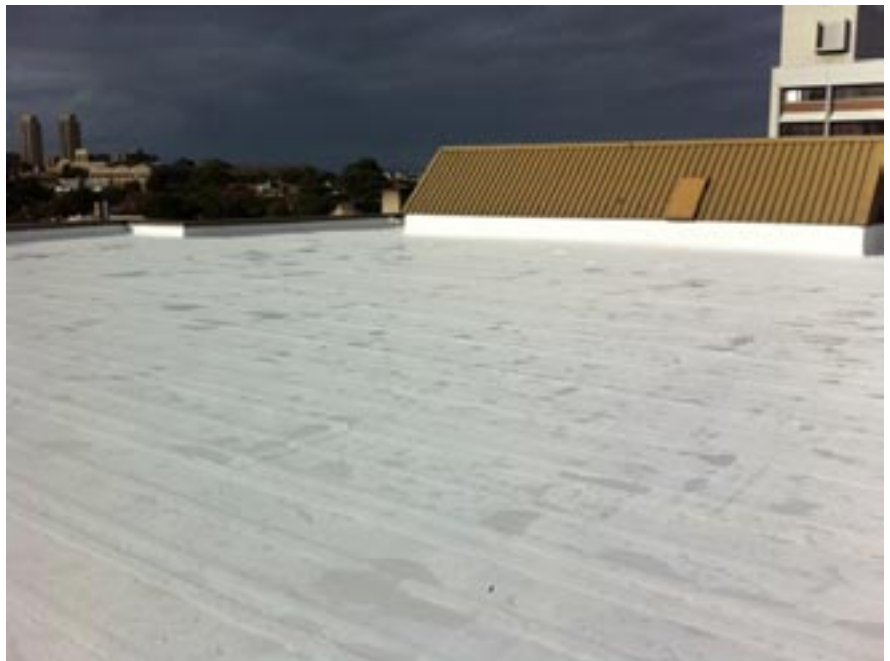
A UV-stable coating was applied

- Cavity flashing works
- Remove the existing membrane and prepare the slab including priming
- Install a two-layer waterproof membrane system with the top layer being a mineral finish
- Overcoat the entire roof membrane with a UV stable coating.
