CASEFILE

New windows, patio doors and facade works add value to Bellevue Hill residential property

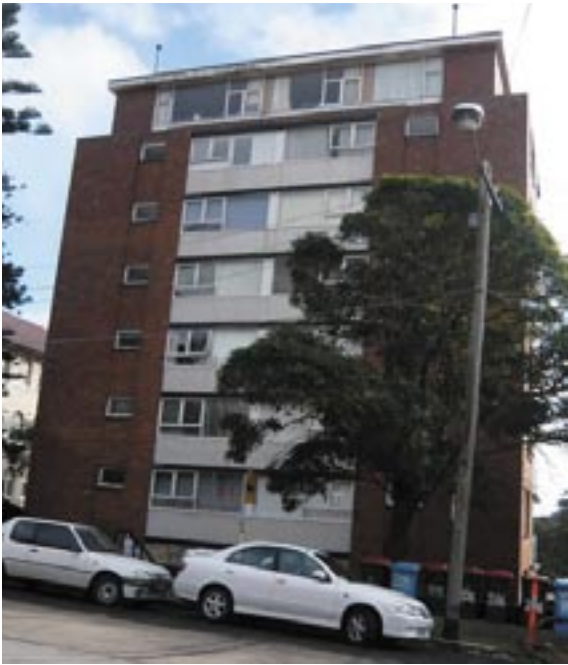
Front elevation before compares with...

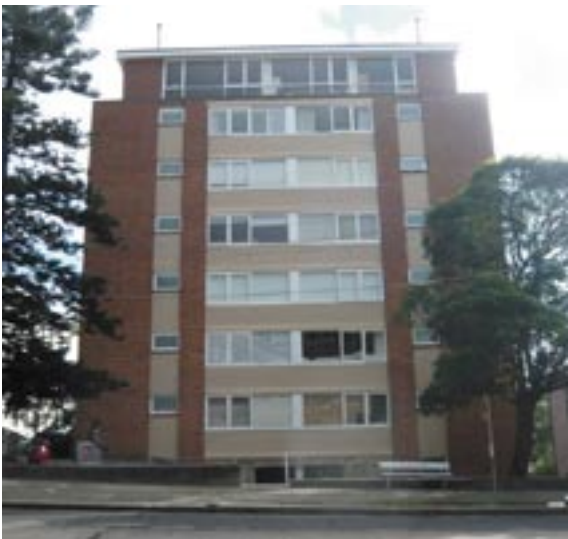
...the front elevation on completion

The workteam removed and replaced all patio doors and windows with new commercial grade aluminium systems, undertaking associated internal work to reveals such as patching, painting, removing and replacing blinds and shutters, and creating new door thresholds where required. They cleaned all facade brickwork, replacing some. A trial of various mortar colours preceded repointing of all facade brickwork.

The team painted all previously painted elements including handrails and metal window. They removed old spandrel tiles and installed a new tile system to enhance the building facades, including over the front elevation brickwork. They undertook some plumbing and minor other

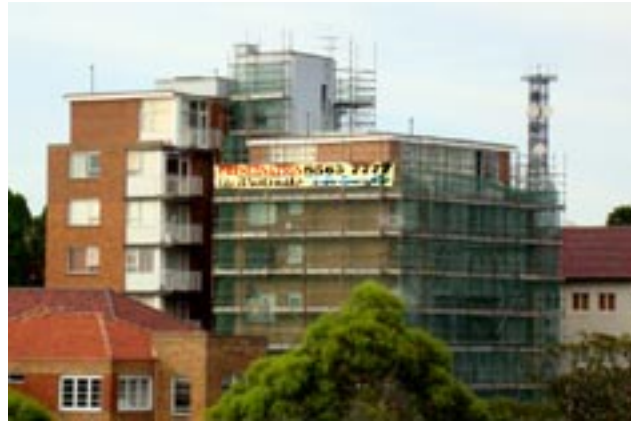
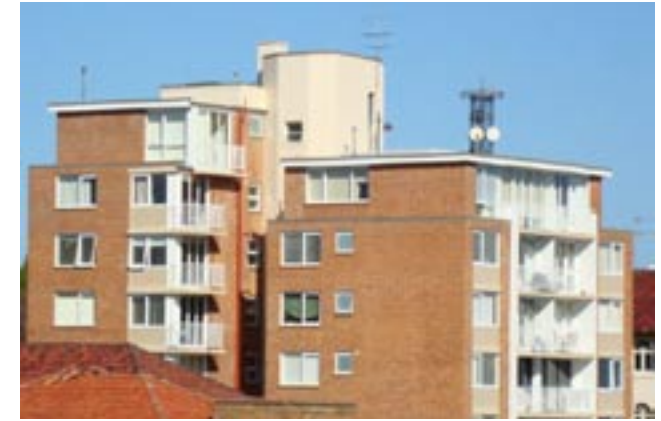
Work-in-progress on the side and rear elevations (left) resulted a value-added improvement (right)

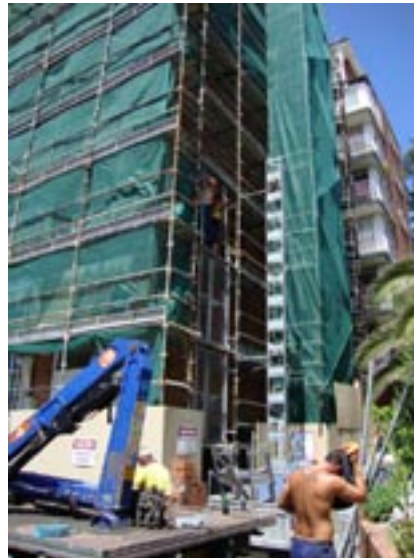
Stage one works to rear tower

The building has two effective tower blocks with a central stair and lift shaft joining them. The works started to the lower tower with the erection of a fully fixed scaffold and materials hoist. These were moved to the front tower on completion of stage one.

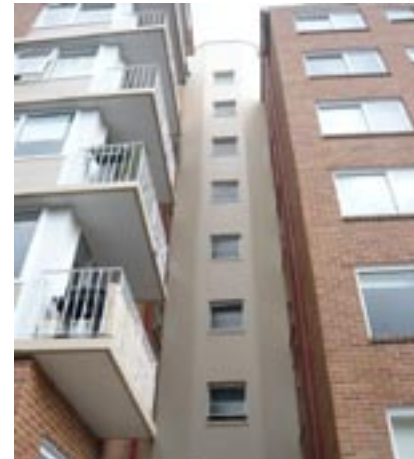
Lift shaft exterior done

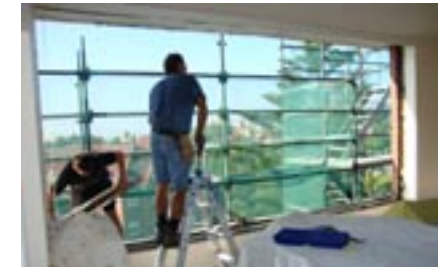
Large window sizes

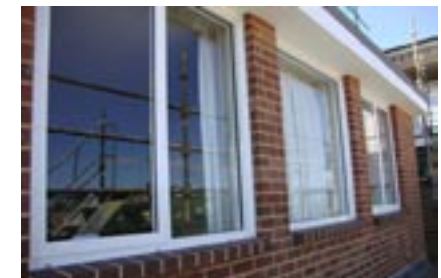
Typical window installation

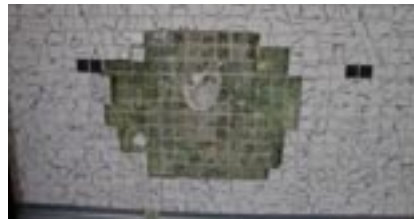
Old spandrel tiling

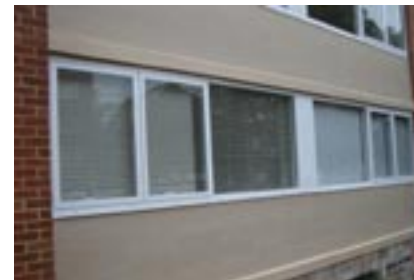
Spandrel tiling and window
