Residential beach facade repair and protection

Project consultant: Bellmont Facade.

Completion: March 2008.

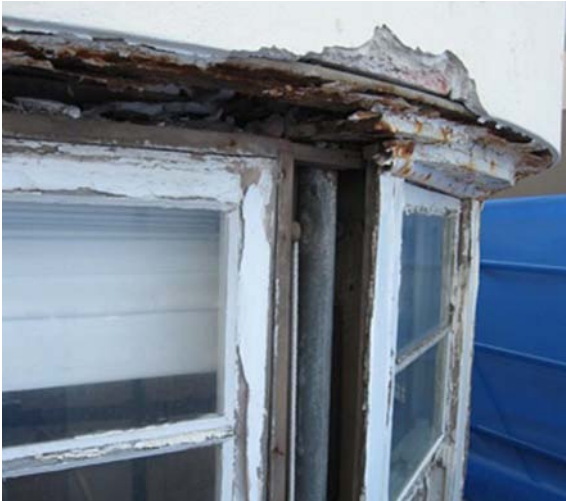
The curved lintel area had badly deteriorated

The methodology: A fixed scaffold was erected to the two elevations and the old lintels removed and replaced with prestressed clay lintels, new flashings

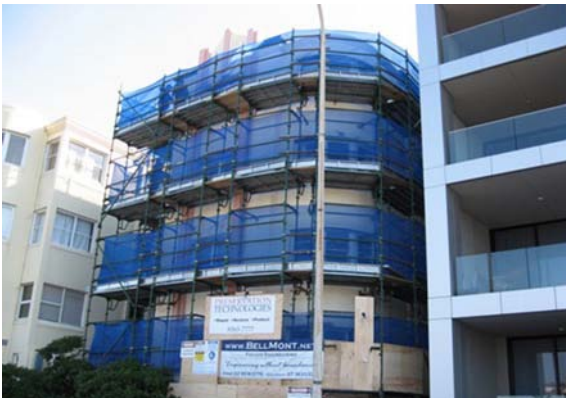
Scaffolding gave access to south and west faces

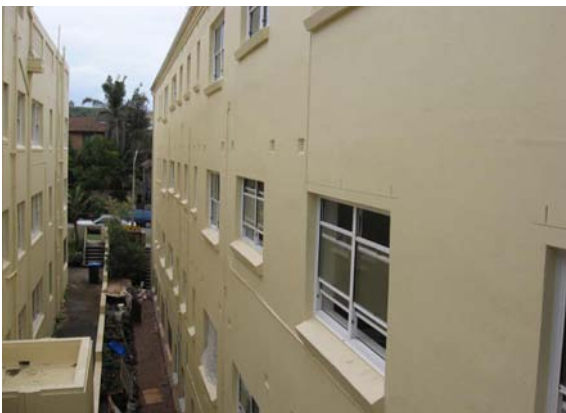
The west elevation approaches completion
