Chatswood brick facade strengthened & upgraded

**Re: The Highlander SS 63393
6-8 Freeman Road, CHATSWOOD**

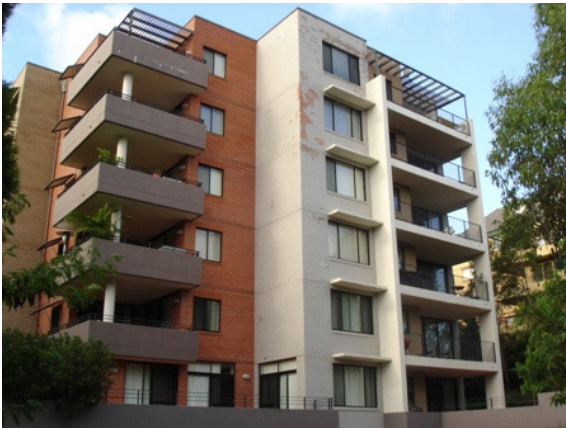
Eddy Avenue elevation prior to repair

The problem: A detailed investigation of all facades revealed severe deterioration of the brickwork mortar bed due to poor quality control over the mortar mix originally. This called into question the brickwork's structural adequacy. Paint was peeling and deteriorating on the walls. At ground level, terraces needed to be membraned to prevent water ingress into the car park below. Render was cracking and delaminating. Internal works and concrete repairs in the car park were also needed.

fully protected to minimise damage. The team repointed all external skin brickwork and installed stainless steel brick ties, including some into concrete elements. They replaced delaminated render with a polymer render system and finished it ready for painting. Peeling paint and delaminating bagging was water blasted, prepared and coated with a waterproof membrane system. Tiles and screeds to two large terraces were removed, the areas prepared and membraned with a PVC system before re-tiling. Minor works and concrete repairs were followed by a major site cleaning exercise to return the building as new back to the owners.

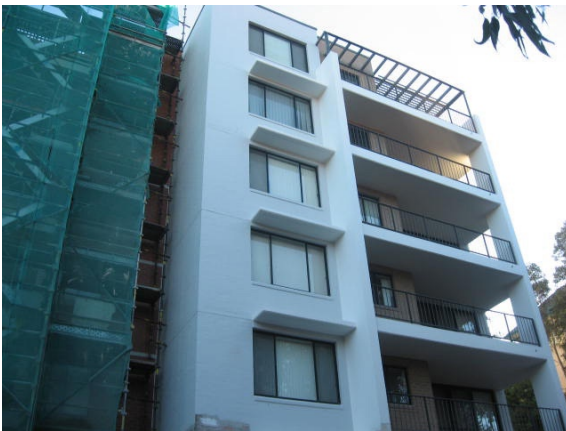
Nearing completion repair and protection

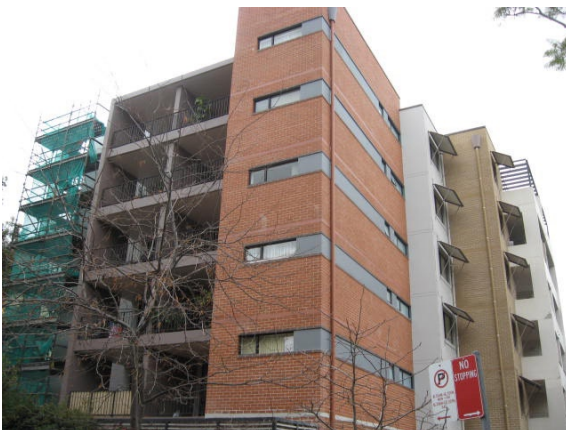
Freeman Road brick facade repointed and cleaned
