Kentbridge House gets major face-lift

Main contractor: Built NSW

Completed: June 2008

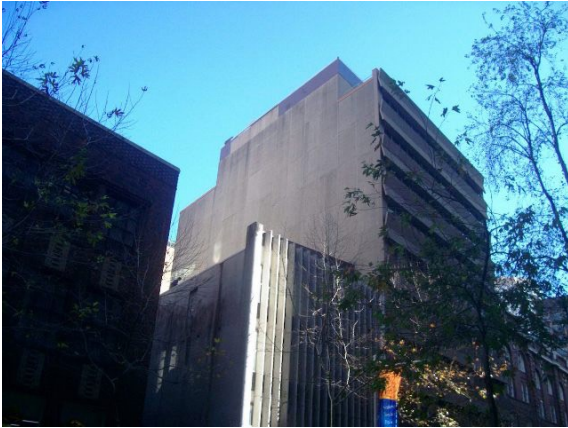
Southern facade prior to protection

The problem: The building had shown signs of facade deterioration for some time. Following a rope access inspection, the Kent Street facade was deemed beyond repair, and high chloride profiles and carbonation attack were found in other facade elements. Major spalling was occurring to window heads and sills.

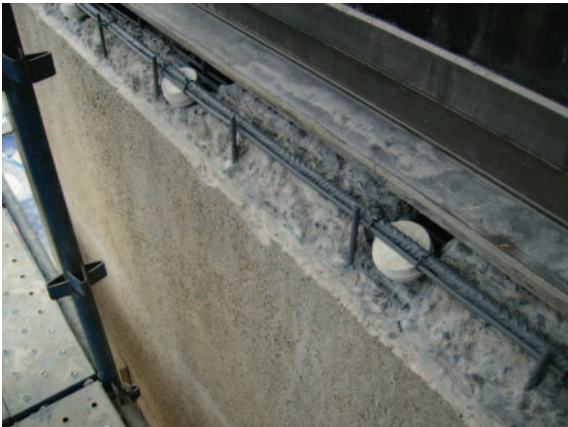
Sacrificial anodes in window sill ready for repair

The methodology: Many swing stages were erected on three elevations with a fixed scaffold system over a B Class hoarding to the north west corner to provide access for the window head and sill repairs. Conventional concrete repair and protection work undertaken involved major repairs to window sills and heads and to facade precast panels. Also the removal and reinstatement of all joints and finally the application of a protective coating system.

- concrete repair to full length window sills and heads including the incorporation of sacrificial anodes
- concrete repairs to the exposed aggregate façade panels
- removal, preparation and reinstatement of joint sealant to all of the facades
- cleaning down the facades and applying an anti-carbonation coating system

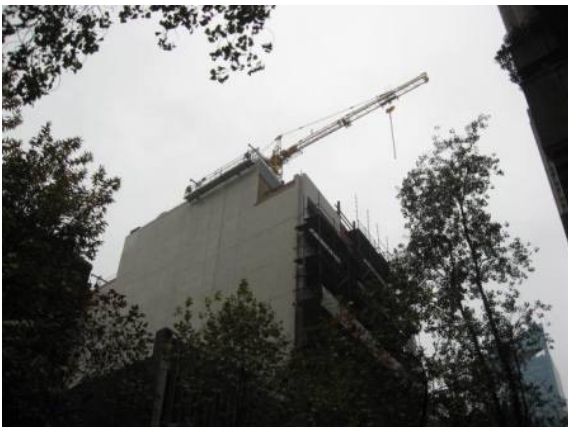
Southern facade repaired and coated

The result: The project met the main contractor quality and safety targets, as well as timelines particularly regarding the removal of the roof level crane, even though the scope increased due to more concrete repair volumes.
