CASEFILES

Beachside apartments revitalised including CP installation

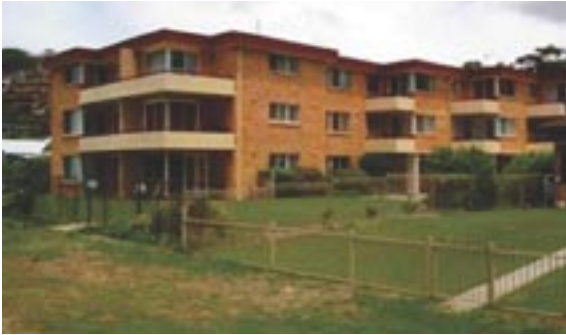
Before: Salt attack promised a limited life and balconies blocked ocean views

The problem: Situated right on the beach, the apartments had suffered some deterioration with salt ingress to external concrete and masonry elements causing corrosion of structural steel. Original masonry balustrades obstructed ocean views and their removal offered the opportunity to raise the overall look of the building and boost property values.

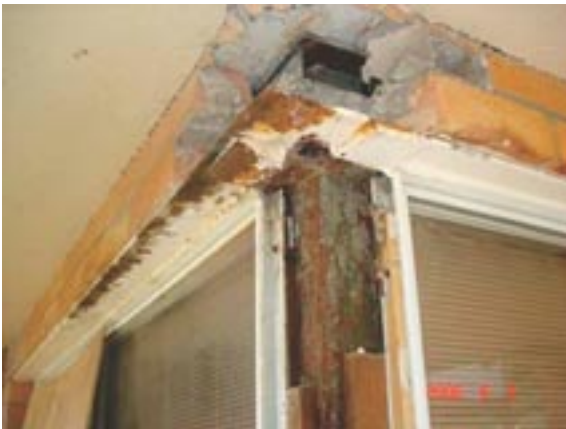
The remedial team exposed the structural steel to inspect the corrosion before repairs

existing masonry balustrades, tiles and screed beds were removed. Deteriorated slab edges were repaired and a new reinforced concrete hob was constructed around each balcony to take the new stainless steel and glass balustrade system. The structural steel columns at each balcony were exposed, prepared and protected. Brickwork was then reinstated and new aluminium column cover plates fixed over the columns to provide further protection. Following the installation of the ICCP system new screeds and tiles were installed. Finally all balcony and car park soffits, eaves and fascias were painted.

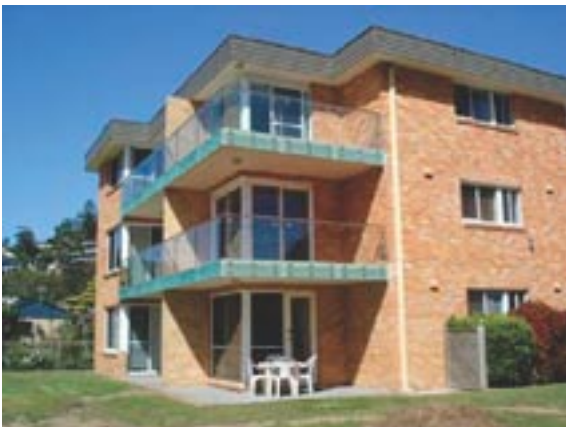
After: Building enjoys a new lease on life and its balconies now give clear views of the ocean
