## Team completes major concrete repairs, roof membrane and landscaping despite tough location

**RE: SHIRLEY ROAD, CROWS NEST  
PODIUM WATERPROOFING AND CONCRETE REHABILITATION**

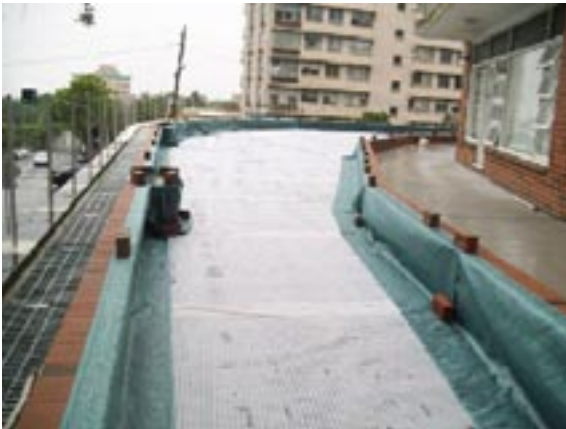
*Podium repairs underway*

**The methodology:** The existing path was removed, the membrane taken into the cavity and new pathway poured. The two layer membrane was also applied over the entire slab. Matching brick dwarf walls were constructed to form the new garden area and also to take the stormwater to drains via a new channel. A drainage cell was placed on the membrane, and new topsoil and grass laid on top. Concrete repairs were undertaken by traditional means and, in some areas, rendered. All car park concrete was cleaned and coated with a high performance anti-carbonation coating.

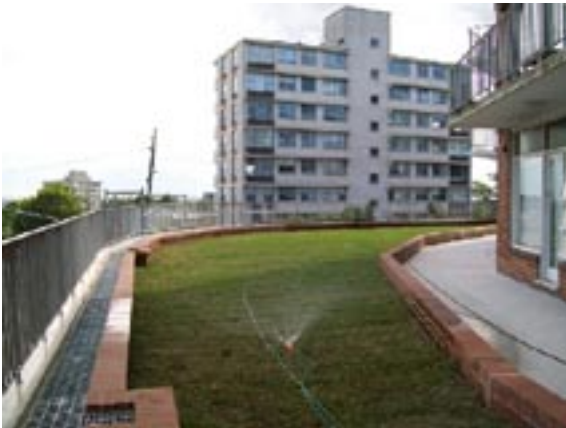
*Podium repairs completed*

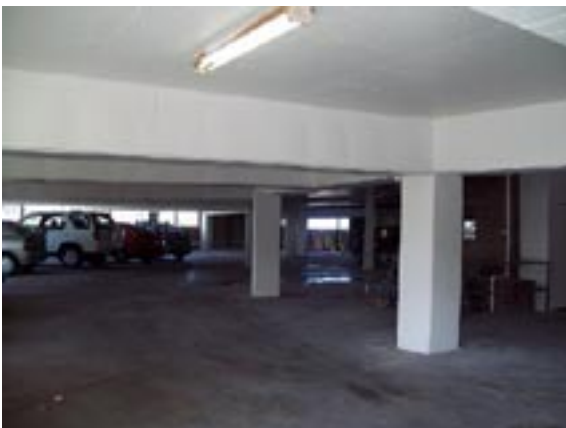
*Carpark repairs completed and coating applied*
